REPORT – 1**REVIEW OF BANJAR PANJI-1 INCIDENT
PLANNING AND EXECUTION OF DRILLING PROGRAM****1.0 SUMMARY:**

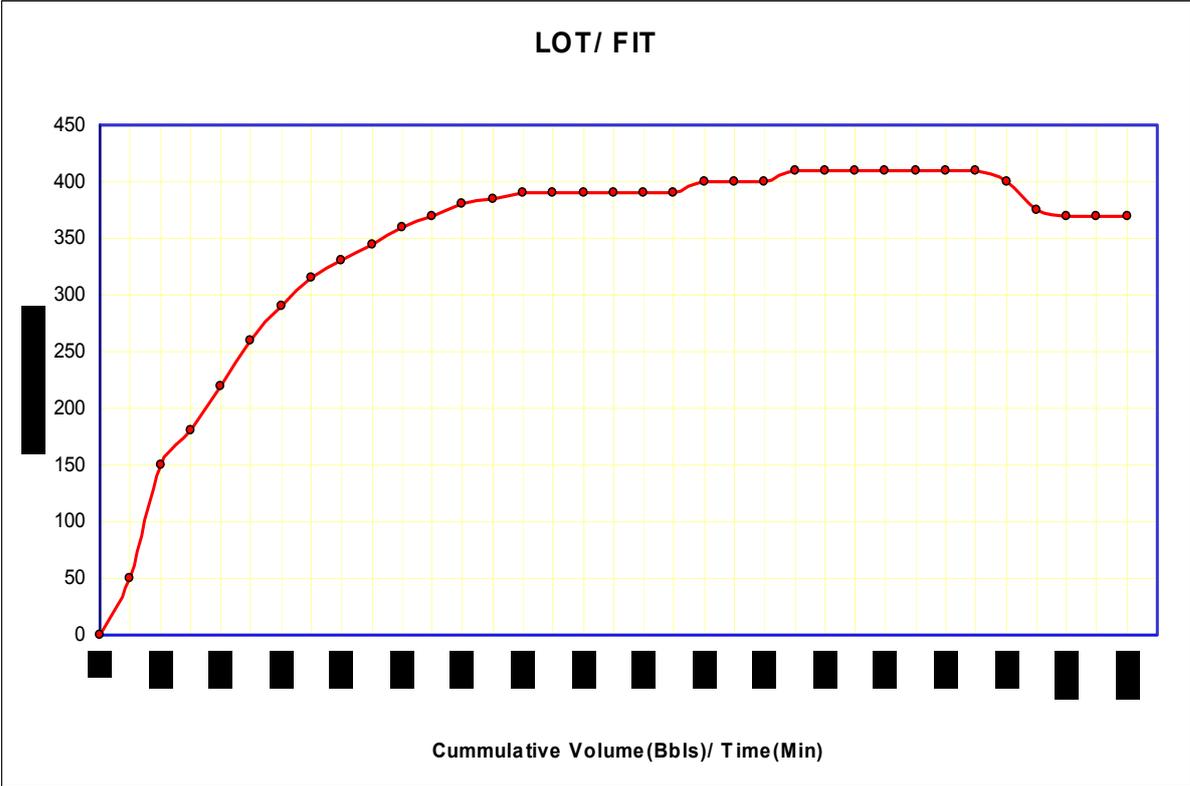
Figure 7: Actual leakoff test data at 13 3/8" casing shoe in Banjar Panji-1 well

Because of a steeper pressure build-up observed in the shallow shale sequence, the 13 $\frac{3}{8}$ " casing was set at a depth of 3,580' - higher than the planned depth of 4,537'. As a routine procedure, a leak-off test was carried out just after the casing shoe was drilled. A leak-off pressure of 16.4 ppg was obtained, which is slightly higher than the 16.1 ppg leak-off test value predicted in the drilling program for the casing setting depth of 4,537'. The leak-off information is shown in Figure 7, and confirms the excellent shale characteristics at the shoe. In other words, a higher LOT value was good news, indicating that the well could resist a shoe pressure higher than expected even for the planned deeper shoe. Table 1 below shows the various casing setting depths and associated leak-off tests.

In the BP-1 well, the LOT value at the 13 3/8" casing shoe was a robust 16.4 ppg, which exceeded expectations. In fact, the shoe test at 13 3/8" was slightly higher than what was expected for the 11 3/4" casing shoe in the original drilling plan.

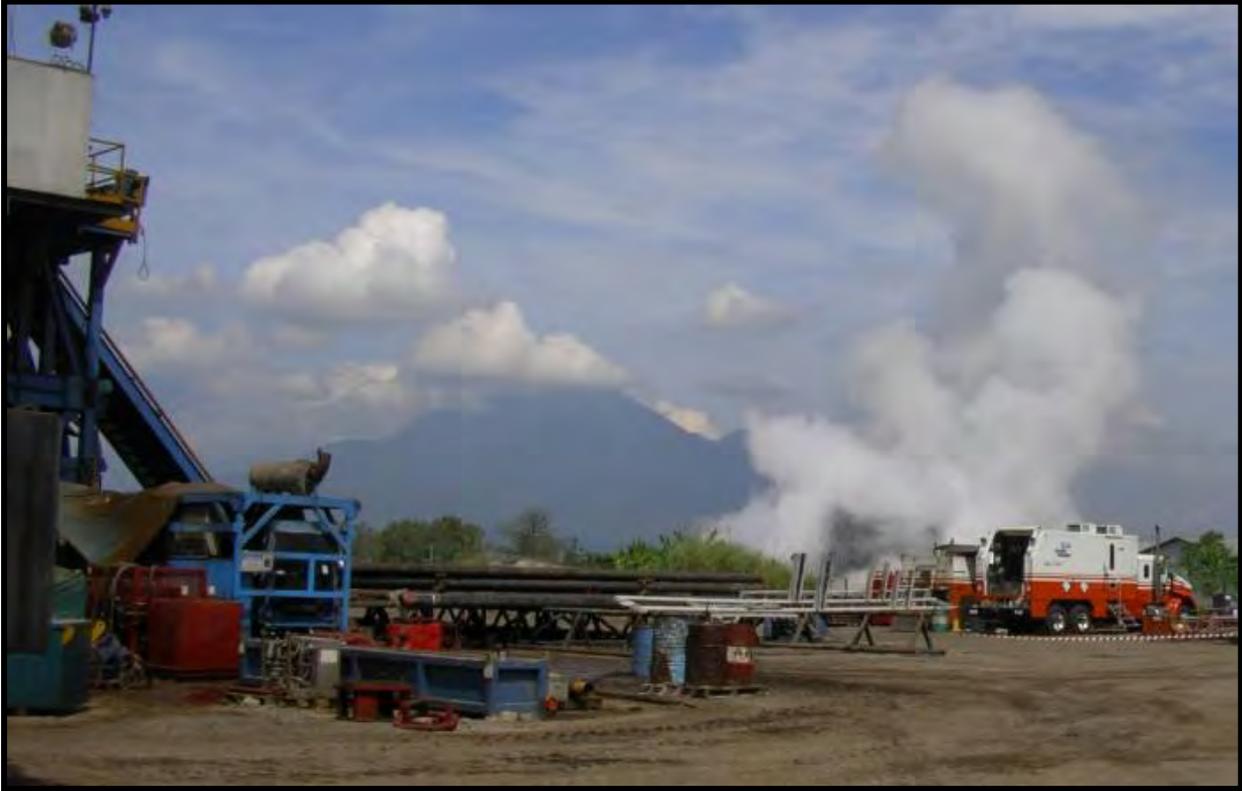
Figure 8: Surface breach & fumarole 200 meters away from the rig on May 29th, 2006

Once the well was dead, an attempt was made to resume the pull-out procedure; however, the pipe was stuck. The rig crew worked the pipe with a maximum pull of 400,000 lbs, but without success. Several other procedures including jarring and spotting a high-viscosity drilling fluid pill were tried for 20 hours, but without success. Then, gas and water (plus steam) – a fumarole – broke out at the surface 200 meters away from the borehole at 03:30 hrs on May 29th, 2006 (Figure 8).

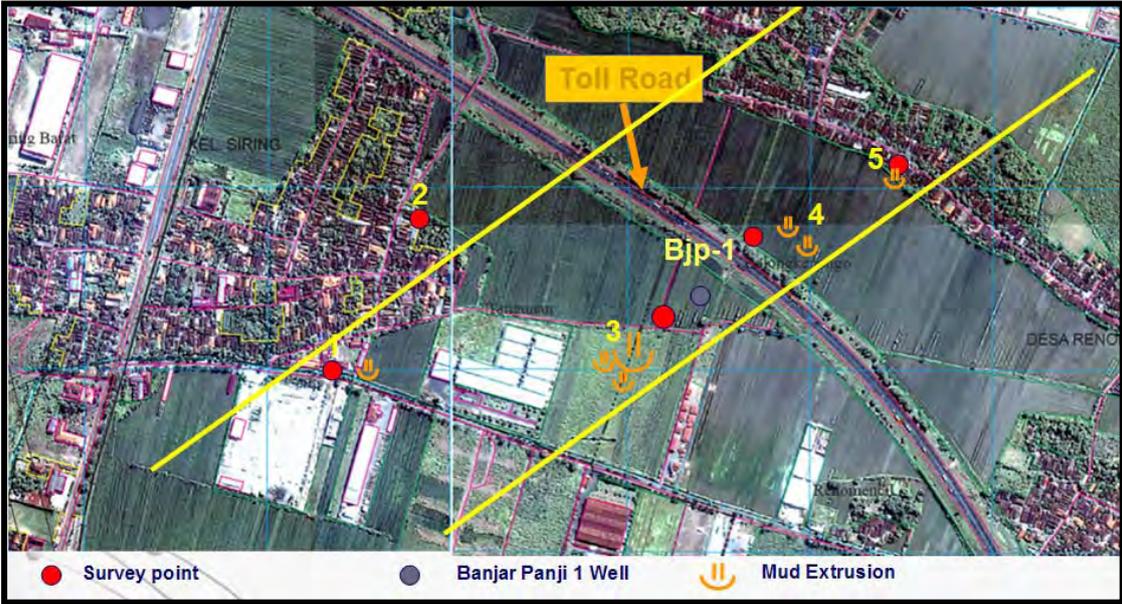
Figure 9: Two more fumaroles initiating parallel to a fault line, including the relative location of the well

Attempts were made to pump weighted mud through the drill pipe to control the flow out of the fumarole, but no connectivity was observed with the well, which was dead (neither flowing nor experiencing lost circulation). The flow from the fumarole continued to increase with two other fumaroles popping-up across the toll road, some 500 meters away from the drill site (Figure 9). In spite of trying to pump heavy mud in the wellbore, no fluid connectivity (i.e. pressure response or fluctuation, inflow or efflux) was observed between the wellbore and the fumaroles. Several attempts were made to pump LCM and cement to control the mud flow rate in the fumaroles but with no success. For some reason, the borehole had become totally disconnected from the induced fracture system that was bringing liquids, gas and mud to the surface as fumaroles.

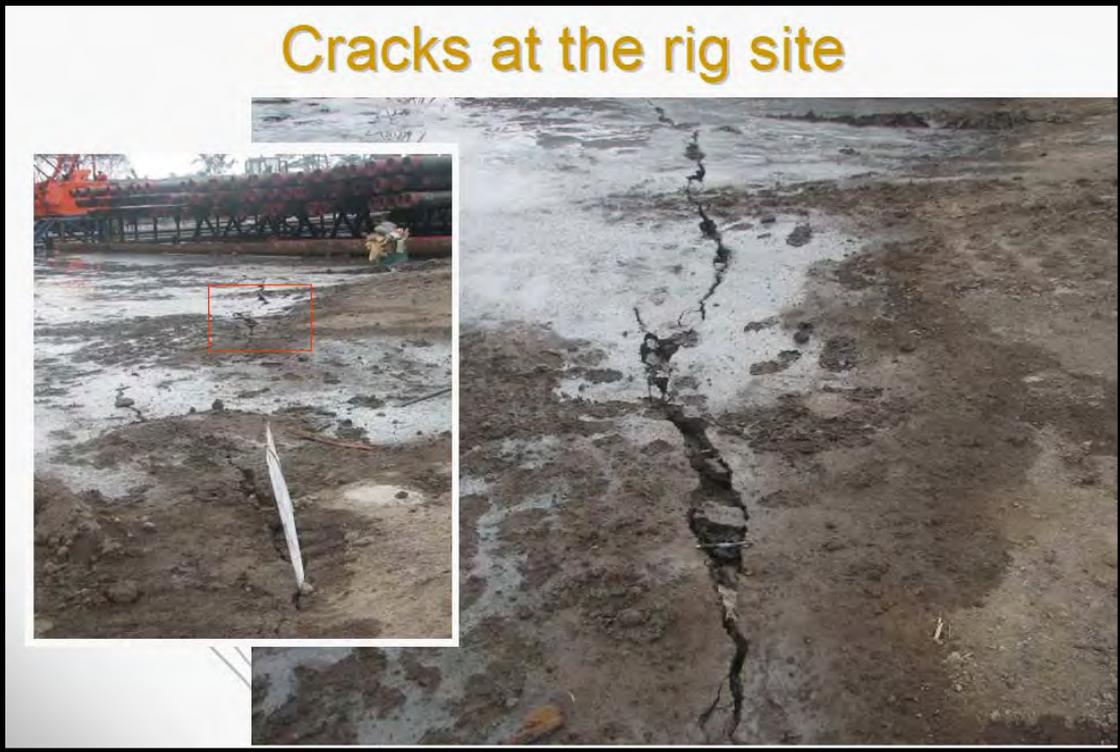
Figure 10
A crack develops near the pipe-rack in the vicinity of the rig

With the flow rates from the fumaroles continuing to increase, the danger of flooding the area surrounding the rig began to increase. A ground crack also was noted around the rig site under the pipe-rack (Figure 10).

With the ground crack under the pipe-rack and mud starting to flow over the berm wall into the drill site, a decision had to be made in the field either to stay on site or to abandon the well and demobilize the rig. The decision was made to abandon and demobilize the rig because of safety reasons. Staying on the well at that time would have served no useful purpose, and would have exposed men and materials unnecessarily to an unknown and dangerous situation. Proper management authorization was secured in finalizing the rig-down command.
