REPORT – 1**REVIEW OF BANJAR PANJI-1 INCIDENT
PLANNING AND EXECUTION OF DRILLING PROGRAM****1.0 SUMMARY:**

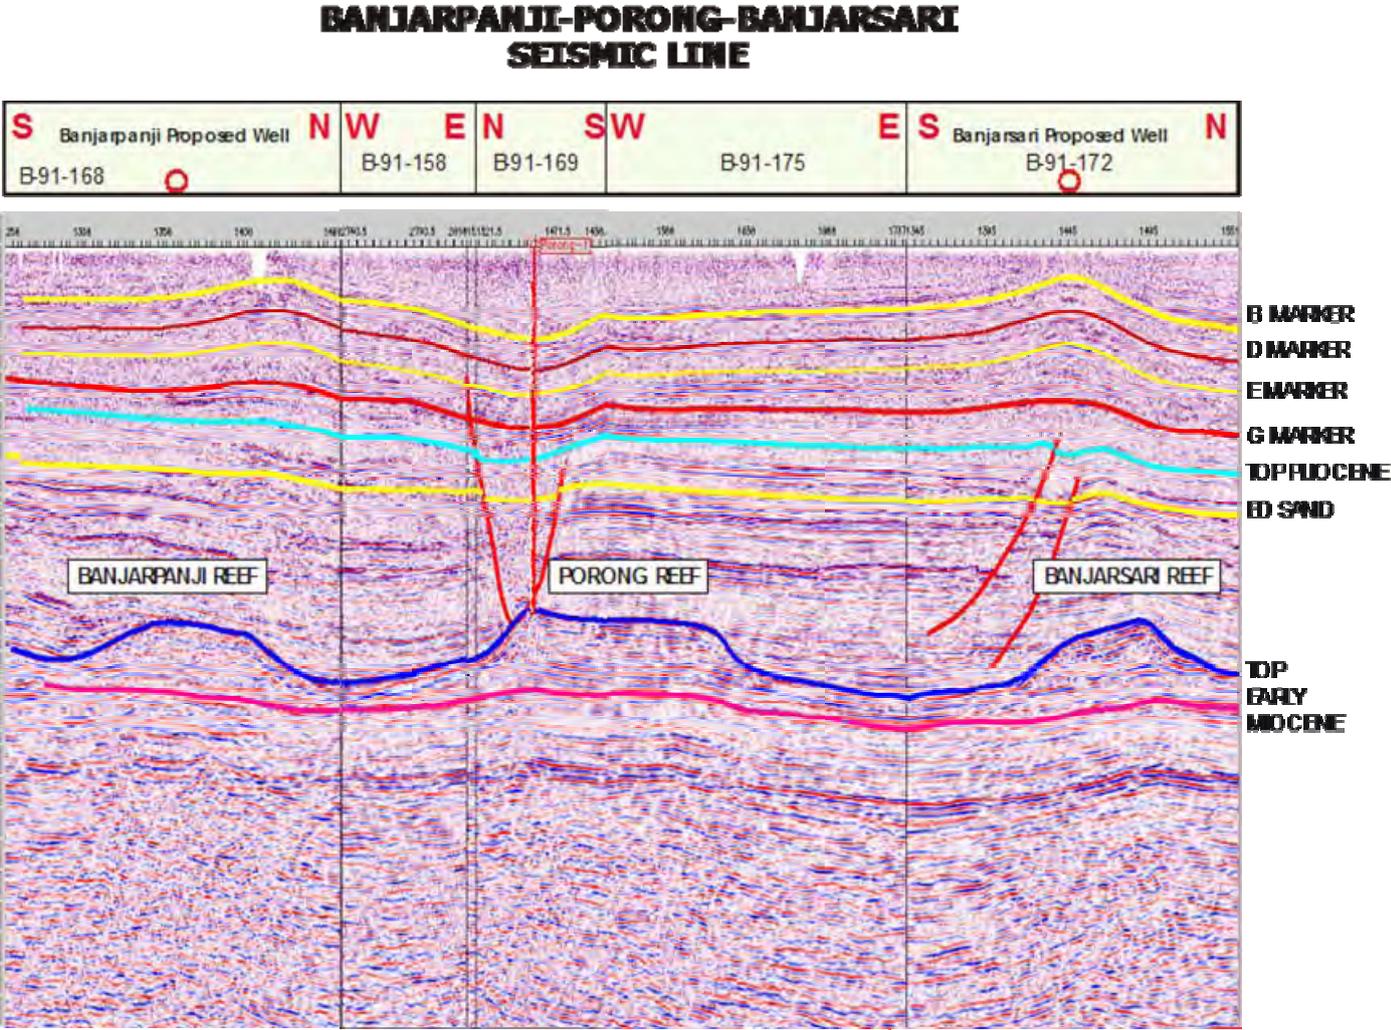
Figure 1 Geophysical Description of the Trend

The lithostratigraphic sequence and general geological setting was expected to be similar to that encountered in the Porong-1 well. A geophysical (seismic) cross-section comparing the two wells is shown in Figure 1. Note that the BP-1 well is in a more defined structure as compared to Porong-1 well. It appears that Porong-1 well was drilled close to the remnants of a fluid migration chimney. Such geological settings are prone to borehole instabilities and more variation in rock properties and *in situ* stresses. A better defined structure, such as in BP-1, would in general indicate fewer borehole stability issues and better well control characteristics.

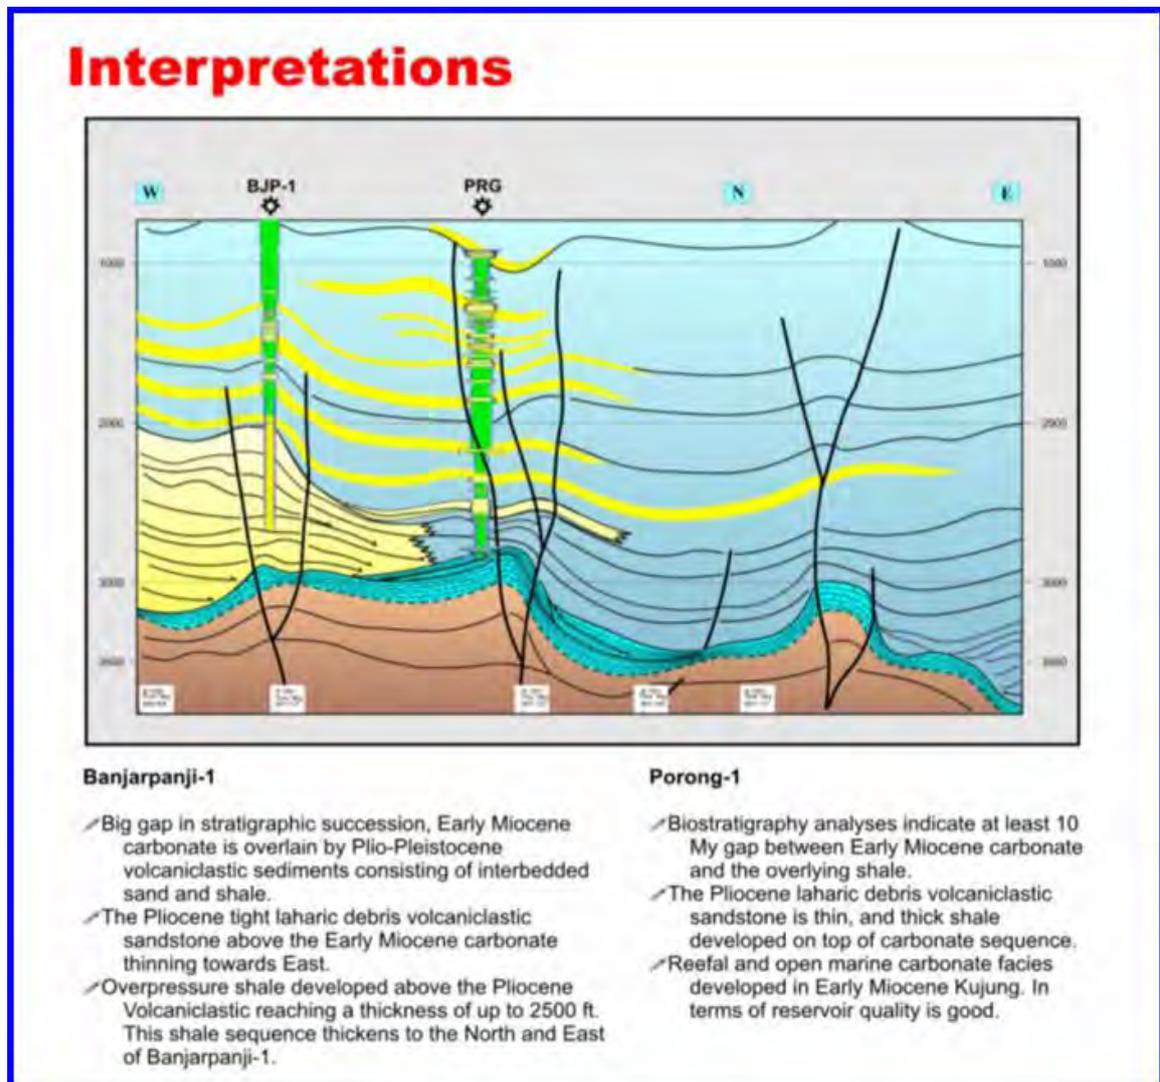
Figure 2 Geological setting comparisons between Banjar Panji -1 & Porong -1 wells

There was, however, a major difference between the BP-1 and Porong-1 wells: BP-1 well encountered an unexpected sand package below the shale prior to entering the target Kujung Formation, shown in Figure 2. The sand package is thick – 2,800' (approximately from 6300' to 9100') – and turned out to be hard volcanic sandstone. It appears similar in nature to turbidites, and may represent lahar material that came loose from the volcanic mountains in the vicinities and flowed into the depositional area as a liquefied mass. This would turn out to be an important difference as sandstones do not make good caprock (sealing rocks), and tend to act as bleed-off zones for elevated pressures. In contrast, shales are considered to be the source of pressure buildup because of compaction and constrained expulsion of water. They are highly impermeable if they are intact (unfractured), and thus tend to make good caprock.

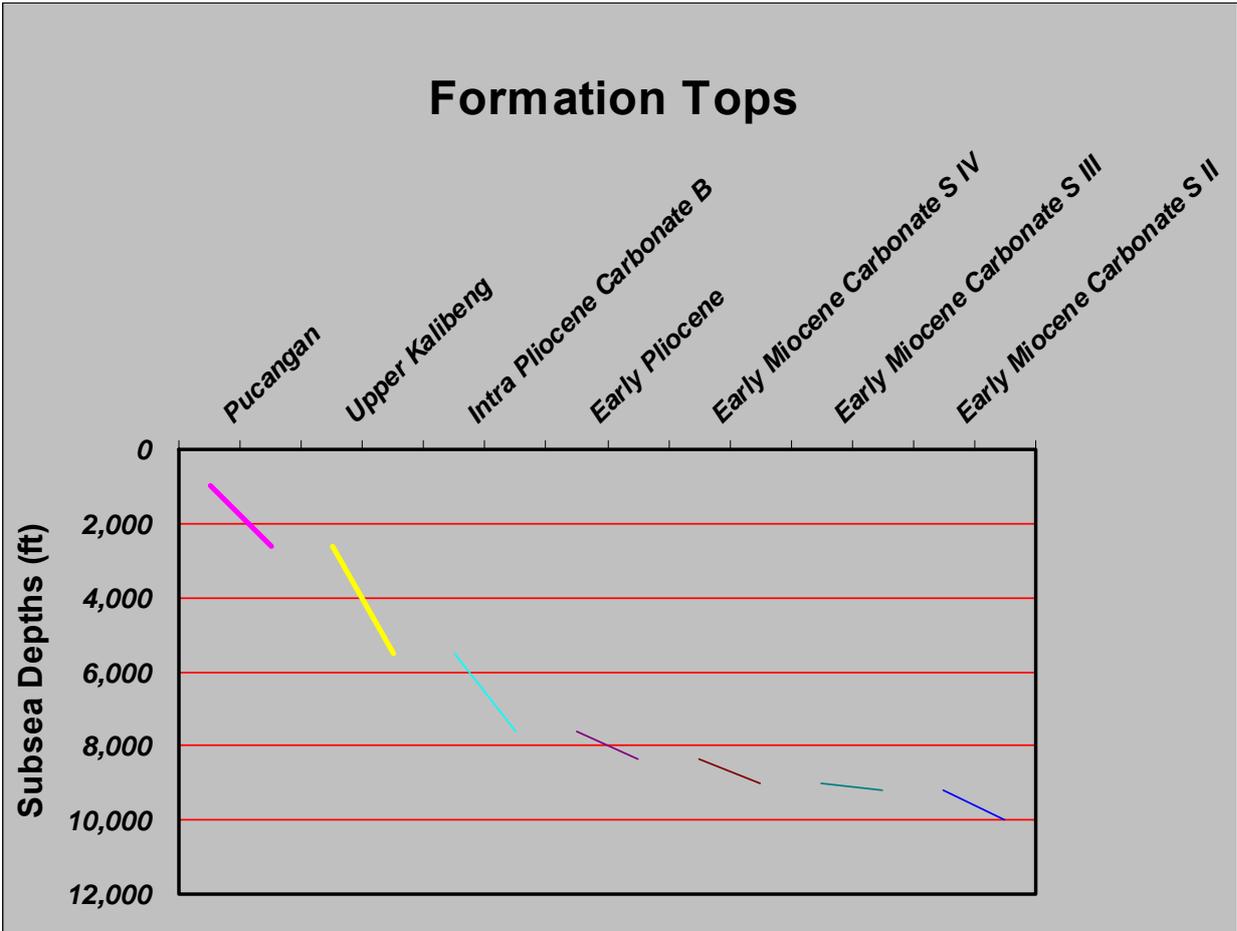
Figure 3 Geological description of lithology expected in Banjar Panji -1 well

Pressure estimates with depth for the BP-1 well were made based on data from the offset wells combined with geophysical log information. Figure 3 shows the geological sequence that was expected to be penetrated during the drilling of the BP-1 well.

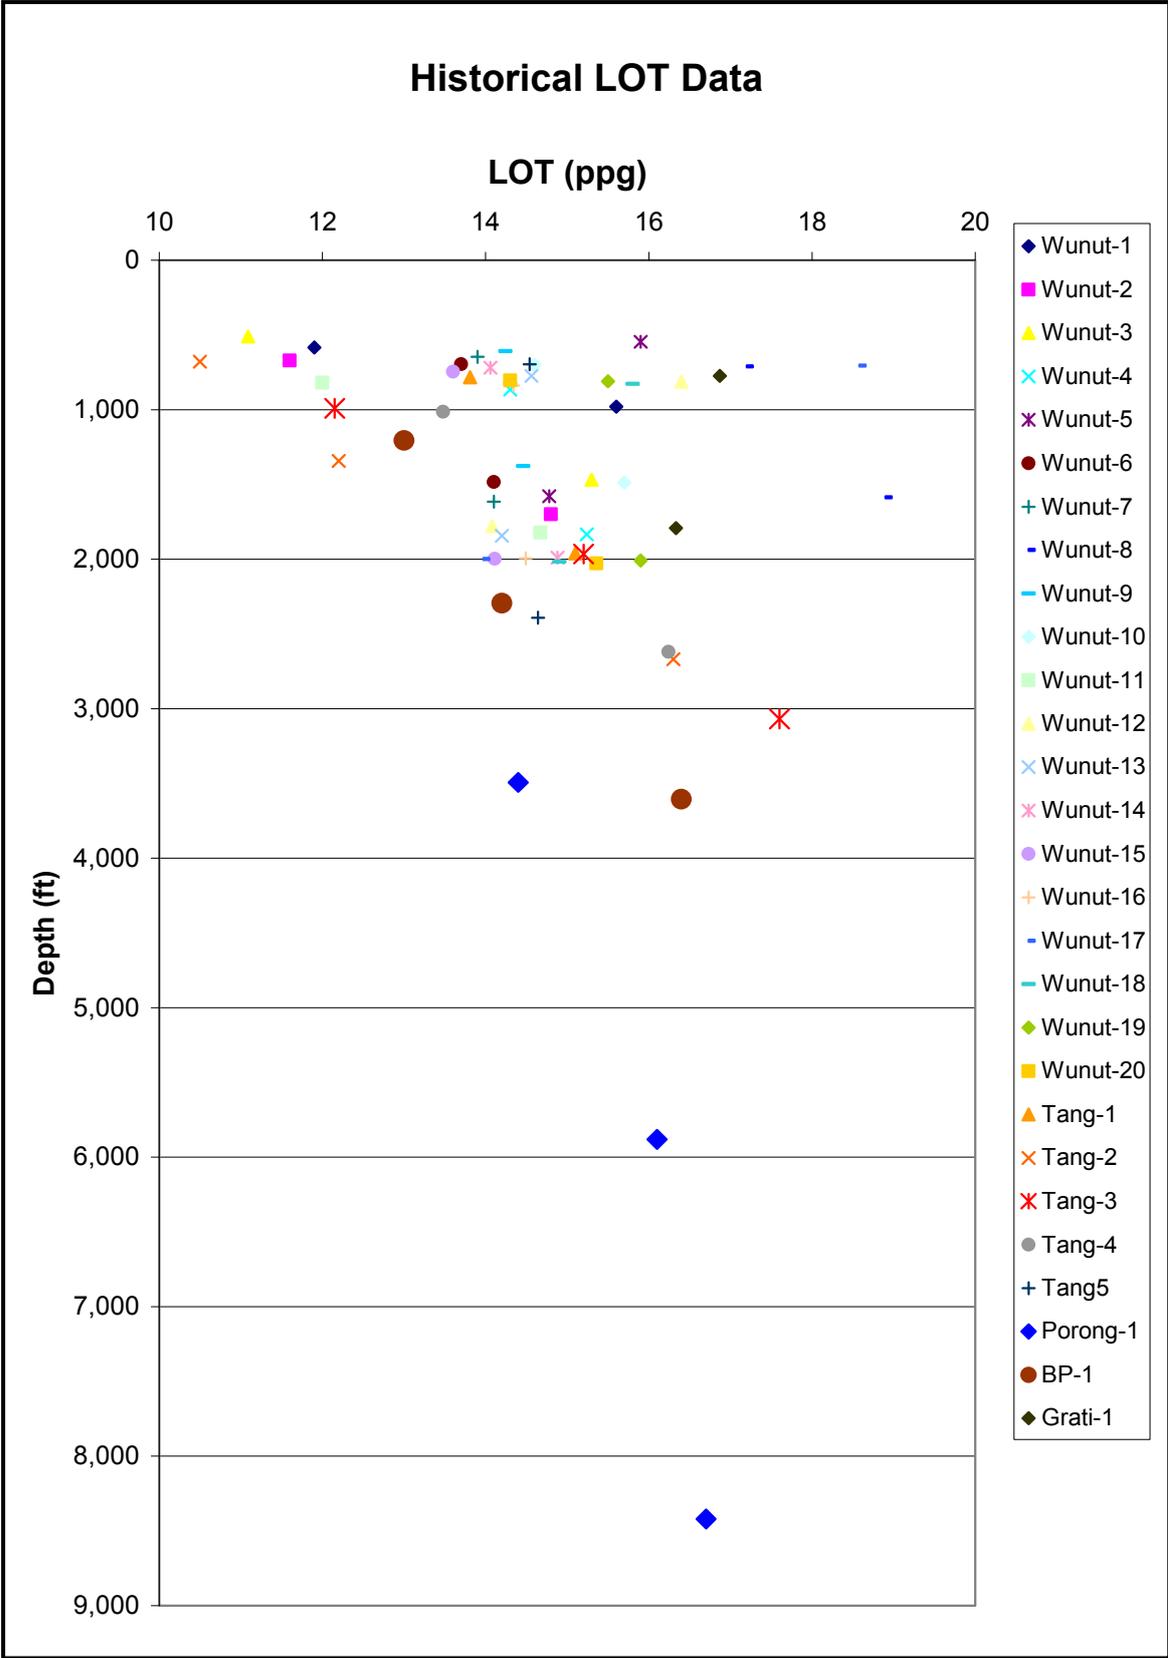
Figure 4: Compilation of historical data on leak-off tests from the region

LOT data was compiled for all the wells; the data available are shown in Figure 4. Both pore pressure and LOT information are considered to be critical in well design and selecting casing points in planning to avoid both blowout conditions and lost circulation through formation fracturing.

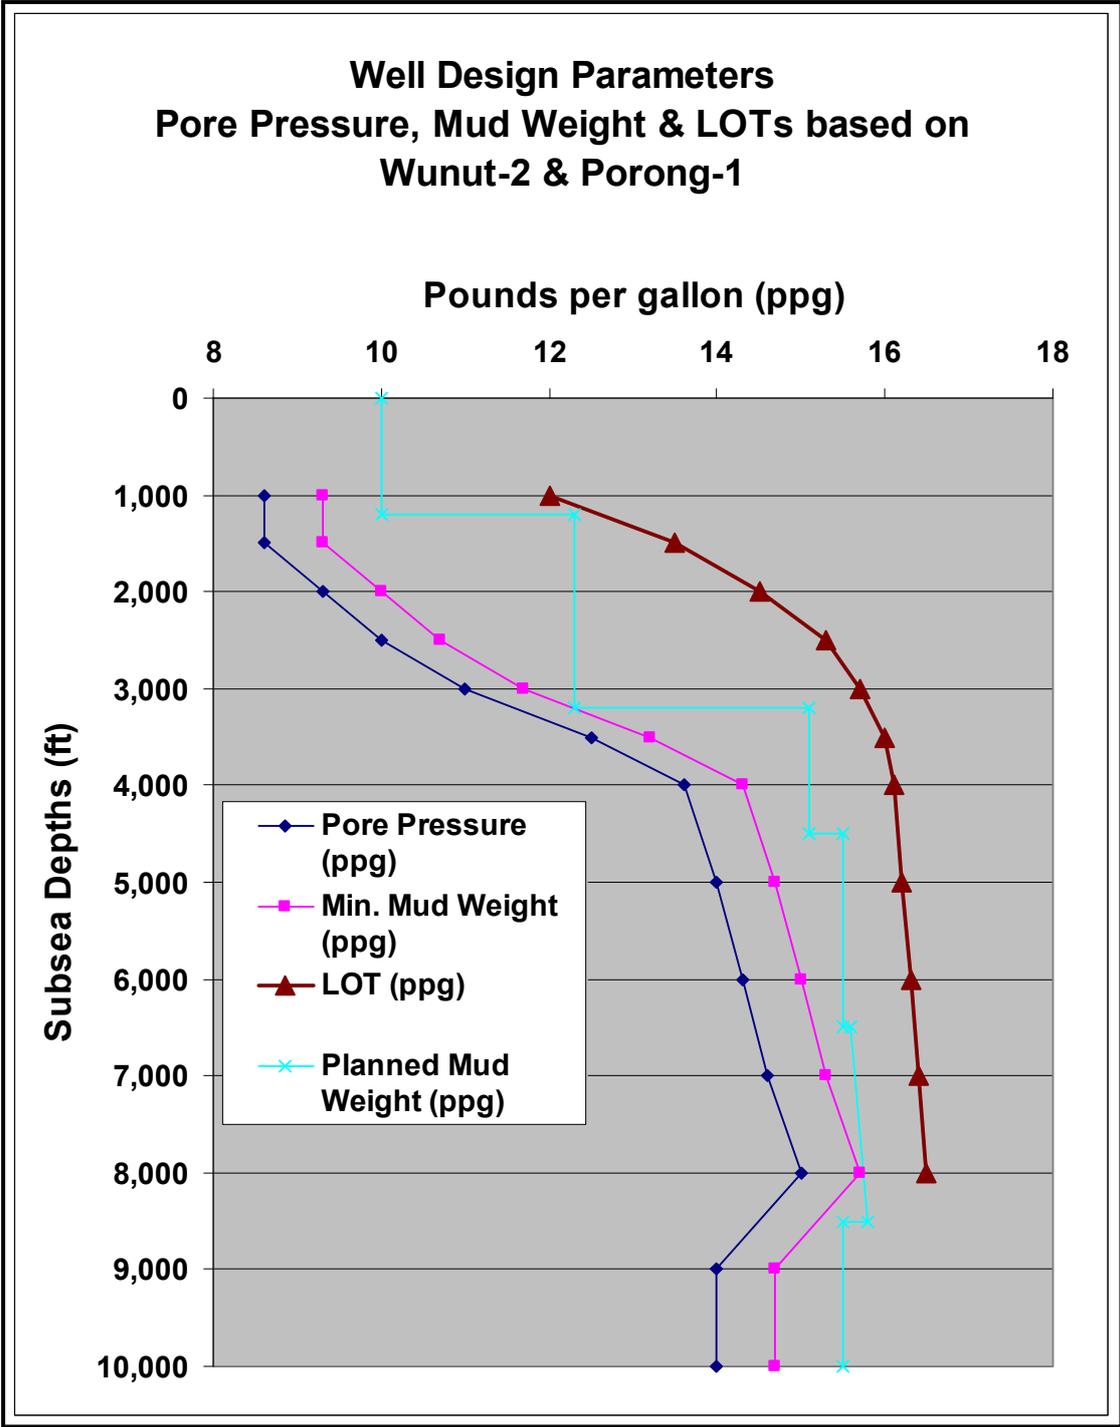
Figure 5

The shallow section of the BP-1 well was designed based on the Wunut 2 offset well, the closest producing well, less than 2 km away. The deeper sections were based on several wells, including the failed well designs for BD-1, KE-11C, KE-11G and Porong-1, as well as the successful well designs for KE-11E and BD-2. A key lesson learned from the Porong-1 well was the existence of pressure regression of about 1 ppg in the fractured limestone that makes up the Kujung Formation. Hence, a decision was made to set the 9 5/8" casing after entering 15 to 20' into the Kujung carbonate, thus isolating the abnormally pressured shales that were expected above the top of the Kujung Formation. However, because of the presence of natural fractures in the carbonate, it was also expected that it might be necessary to set a contingency casing string with a diameter of 7" if a zone of severe lost circulation was encountered below the base of the 9 5/8" casing. This is a common approach, and it emphasizes the need to retain as large a hole diameter as is reasonable when entering the carbonate strata, in order to isolate any unexpectedly severe lost circulation zones. Figures 5 & 6 show the planned well design parameters and the wellbore schematic.
